JULY 1967
REPORT SM-49105-F1

STRESS CORROSION CRACKING OF TITANIUM ALLOYS AT AMBIENT TEMPERATURE IN AQUEOUS SOLUTIONS

YEARLY SUMMARY REPORT
JULY 1966 THROUGH JUNE 1967
UNDER CONTRACT NAS 7-488

MISSILE & SPACE SYSTEMS DIVISION
DOUGLAS AIRCRAFT COMPANY, INC.
SANTA MONICA/CALIFORNIA

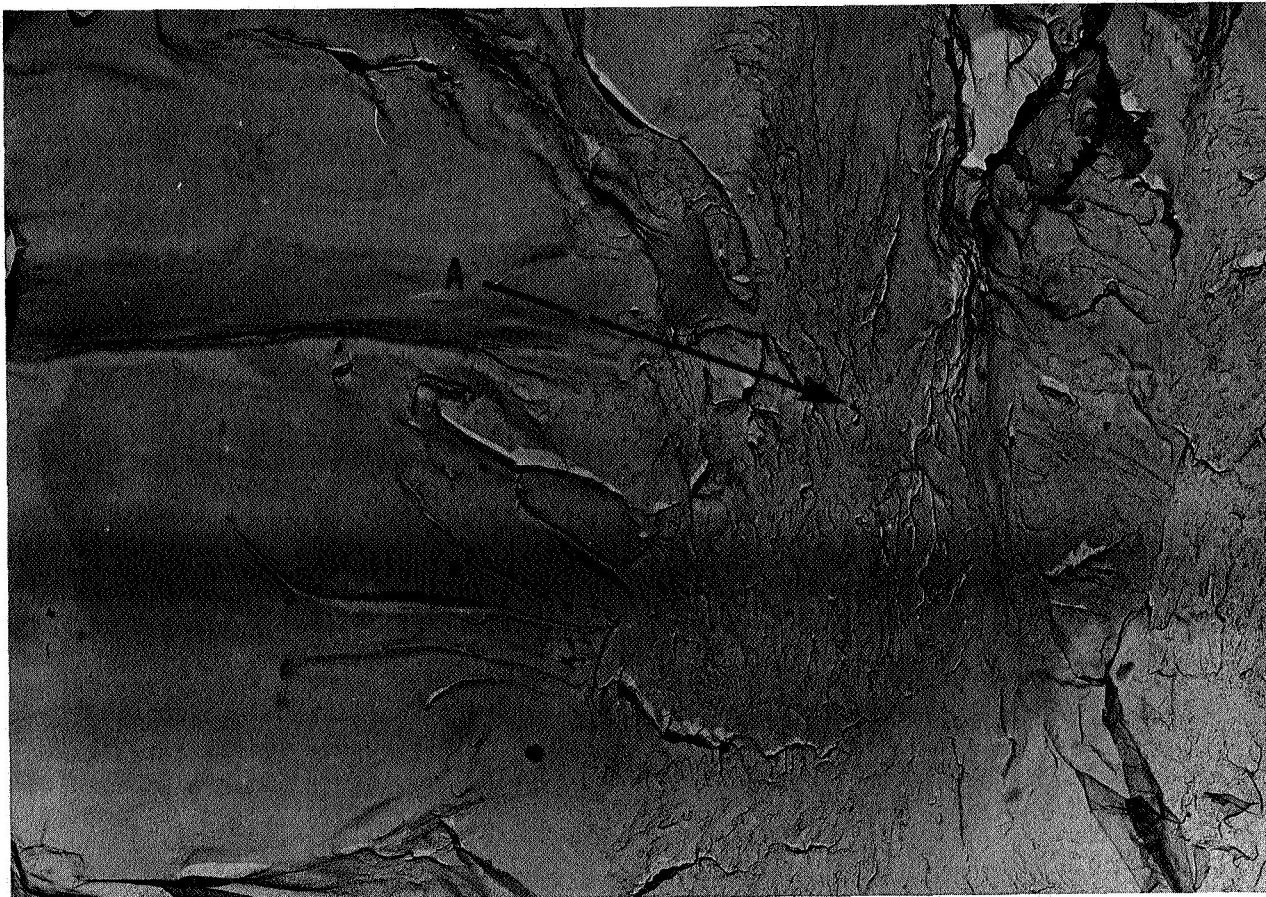
Figure 20. Electron Fractograph from Stress Corrosion Region of Ti-5Al-2.5Sn Fractured in Distilled Water. Most of the fracture exhibits ductile failure (Arrow A) in its local cleavage areas distributed throughout (Arrows B). Magnification 7,500X.

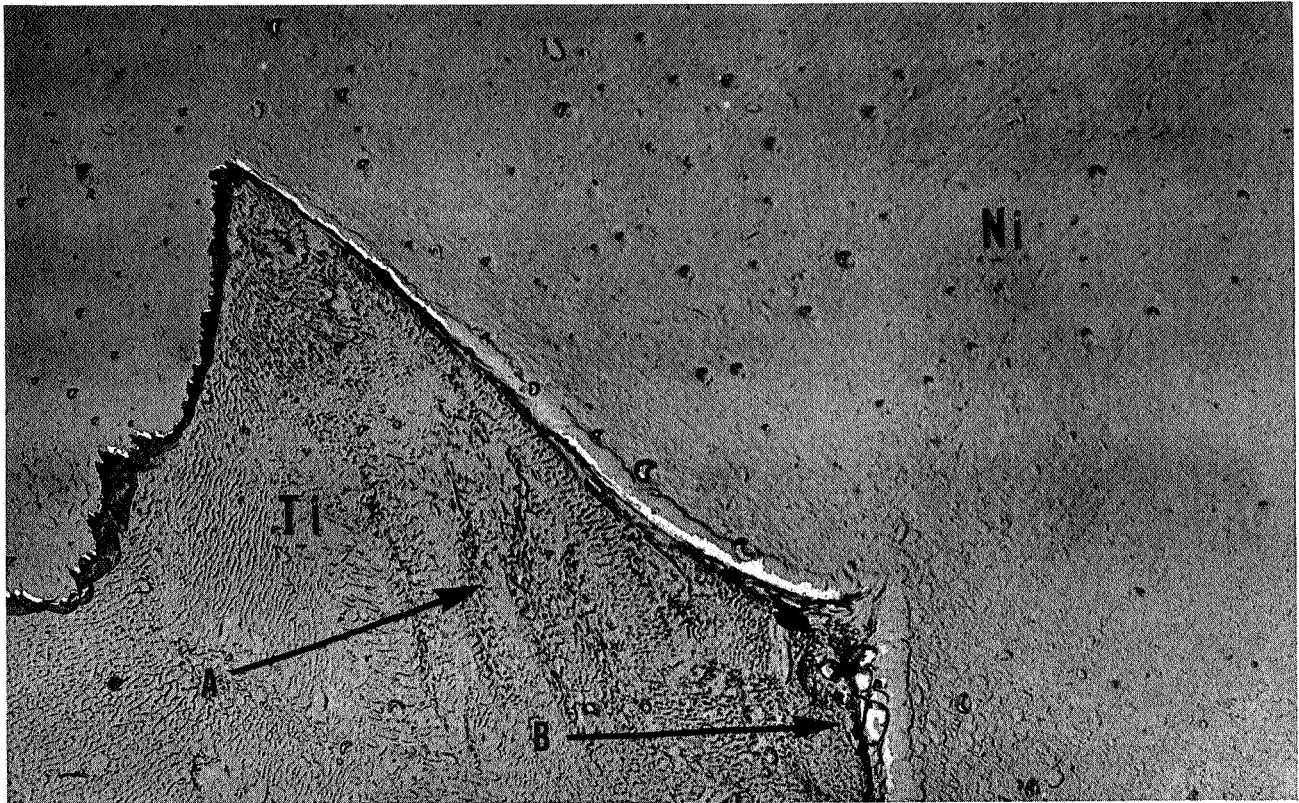
Figure 21. Profile of Fracture Edge of Ti-5Al-2.5Sn Fractured in Air. Arrow A shows deformed region of alpha, and Arrow B shows failure along an alpha-beta interface. Magnification 7,500X.

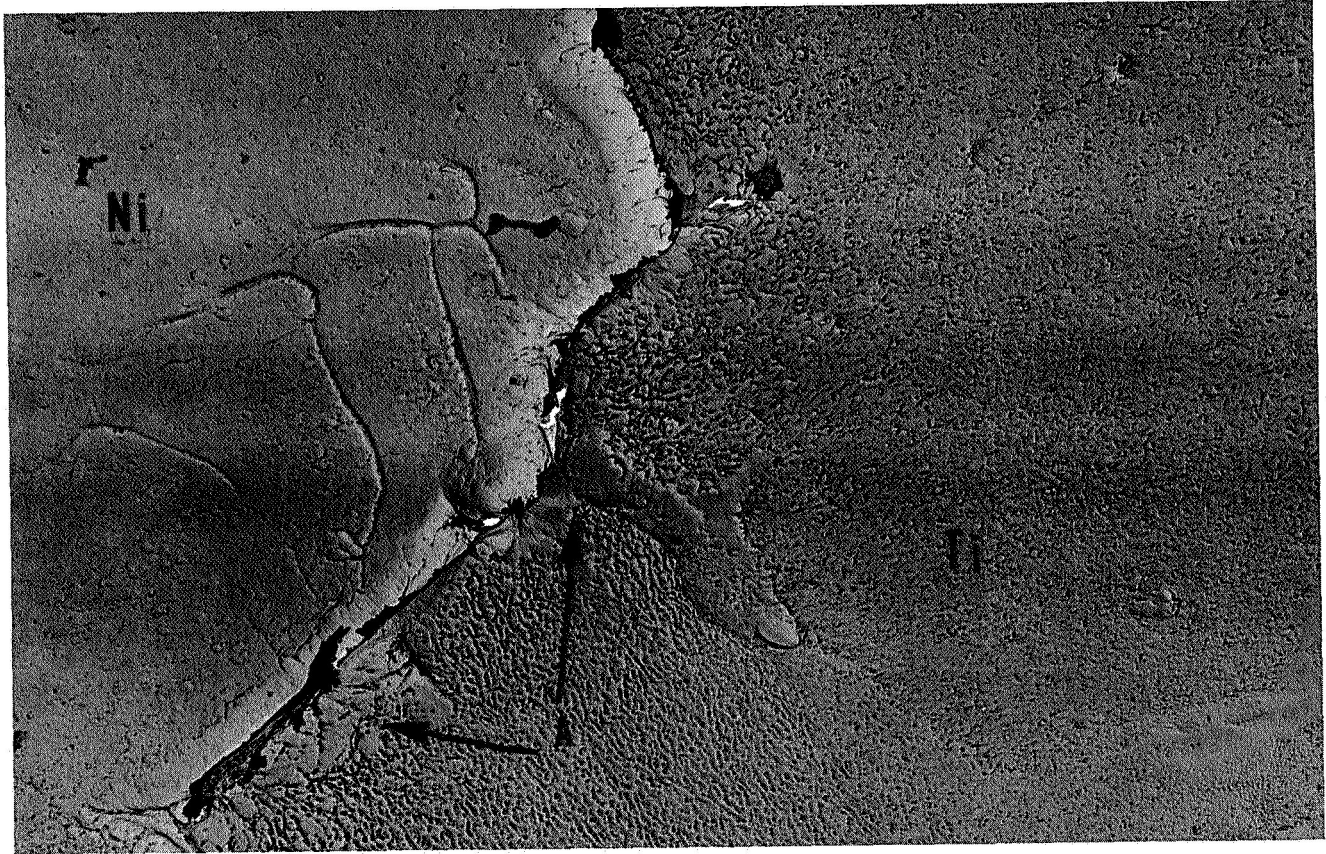
Figure 22. Profile of Fracture Edge in Stress Corrosion Region of Ti-5Al-2.5Sn Fractured in 3% NaCl Solution. In this region (Arrows A), fracture propagated along an alpha-beta interface. Beta particles were precipitated in alpha grain boundaries. Magnification 7,500X.

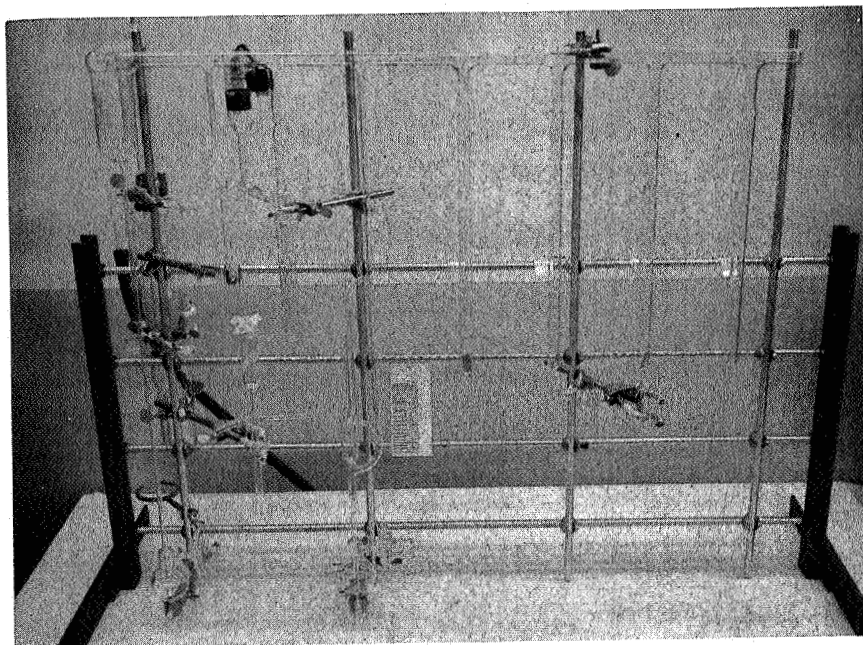
Figure 23. Modified Sieverts Apparatus for Charging Tritium in Titanium Alloys

Tritium gas was introduced into each of the four titanium alloys employing a modified Sieverts apparatus designed and fabricated by Astropower Laboratory as shown in Figure 23. The apparatus is comprised of a forepump, two-stage mercury diffusion pump, ion gage, McLeod gage, tritium inlet system, and sample tubes. A mercury cut-off is used to isolate the vacuum manifold from the diffusion pump. The McLeod gage is accurately calibrated and covers the pressure range from 10^{-3} to 1 torr. The ion gage was used only to determine the ultimate vacuum obtainable in the system during initial outgassing and pump down. The tritium inlet system employs a mercury-sealed fritted glass disc valve to admit the tritium to the vacuum manifold. Individual samples 1/4 inch by 1 inch were pickled in an aqueous solution of HNO_3 -HF and placed in vertical Vycor tubes which were attached to the Pyrex manifold using graded seals. With the manifold isolated from the vacuum pumps by the mercury cut-off, the total volume of the manifold was determined by expanding a known pressure of air (approximately 1 torr)

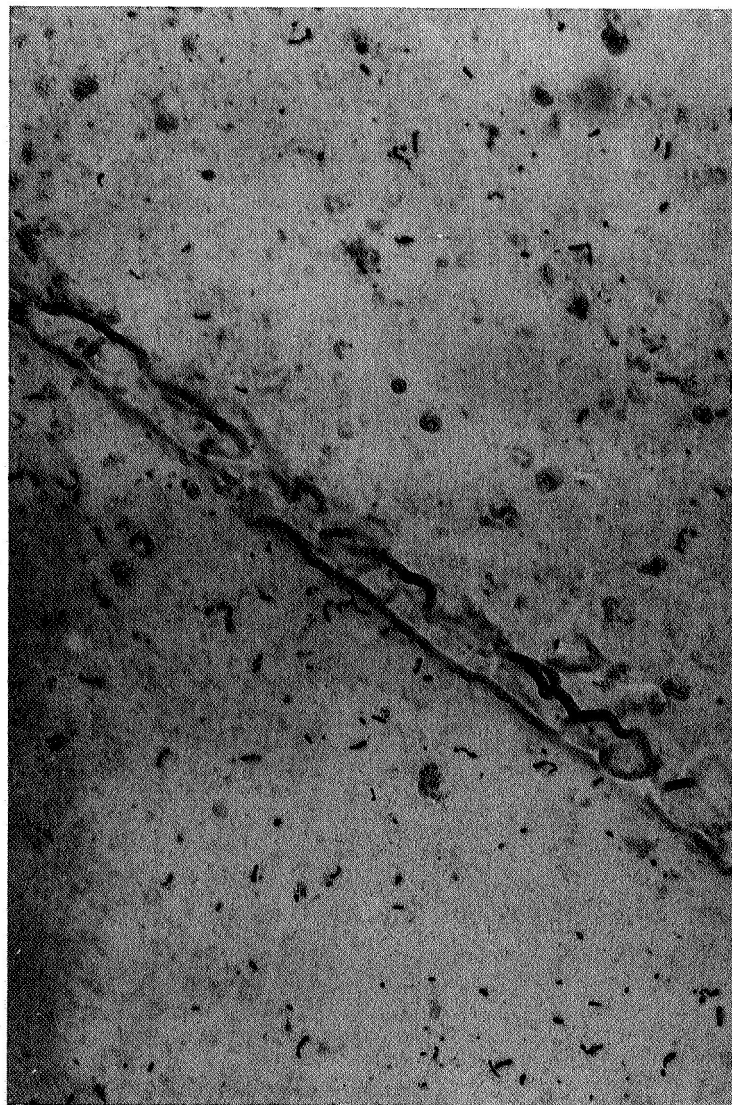
Figure 24. Microautoradiograph of Tritium in Ti-3Al-13V-11Cr. Magnification 20,000X.

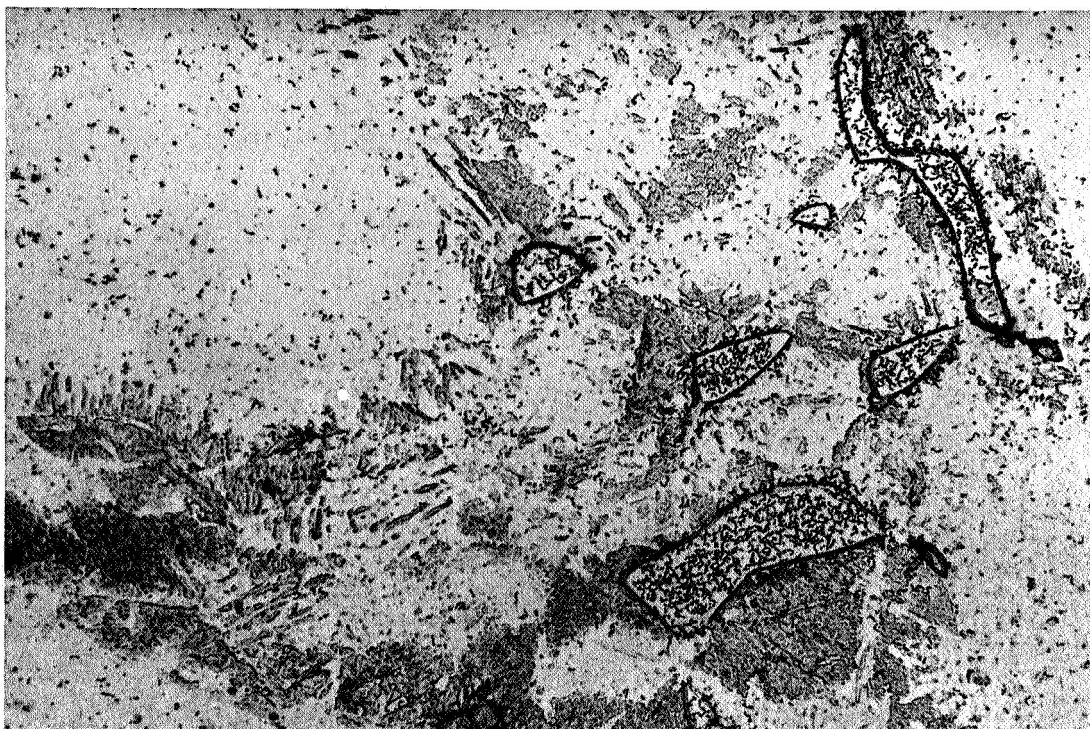
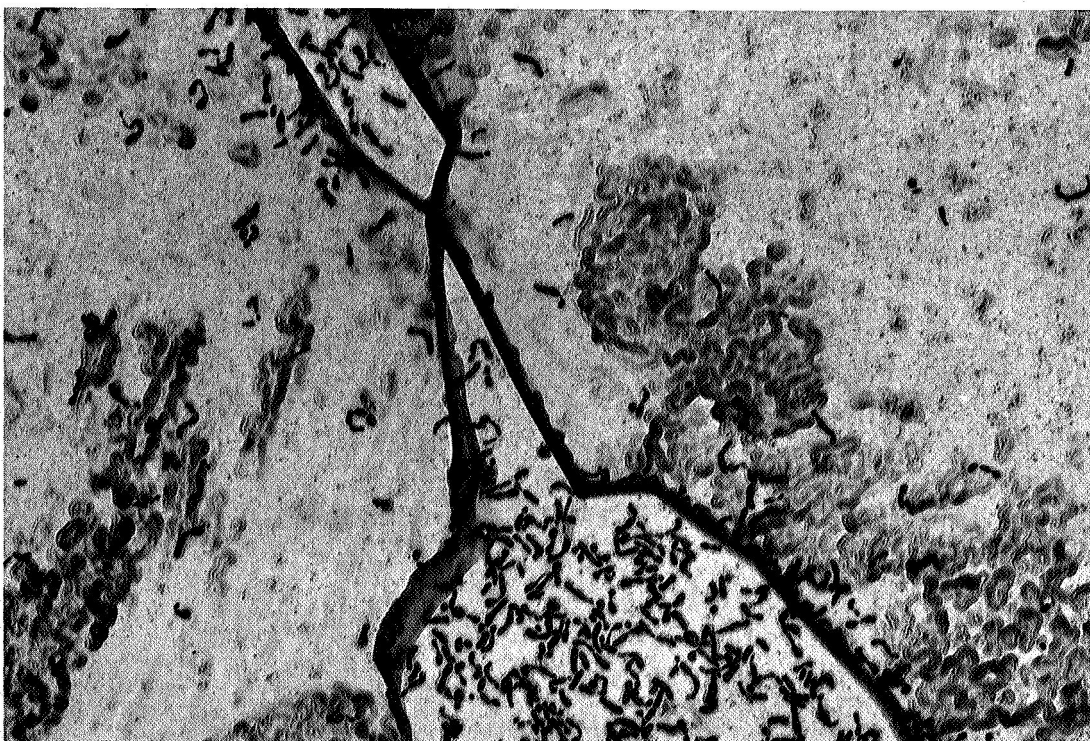
(a) 8,000X
(b) 30,000X

Figure 25. Microautoradiographs of Tritium in Ti-8Al-1Mo-1V. Tritium is concentrated in beta phase.

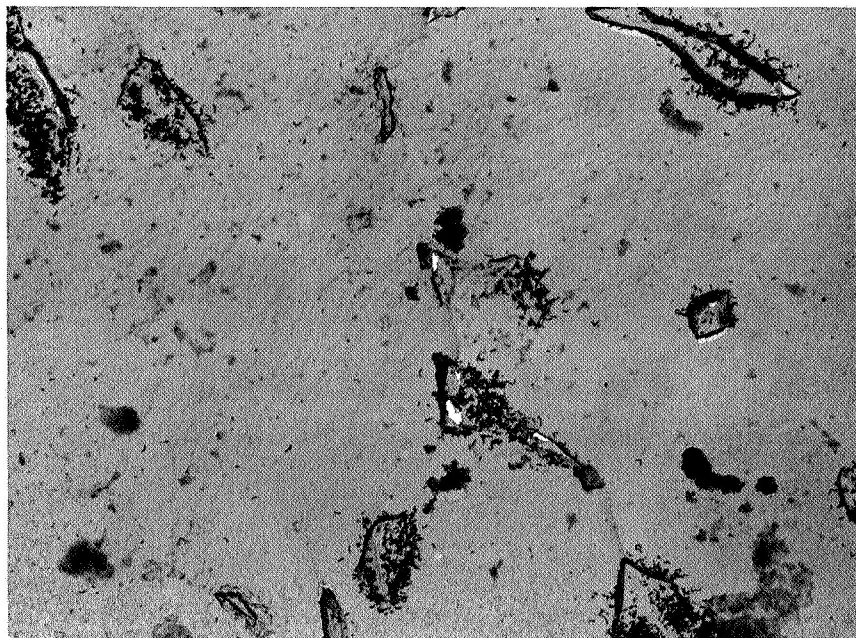
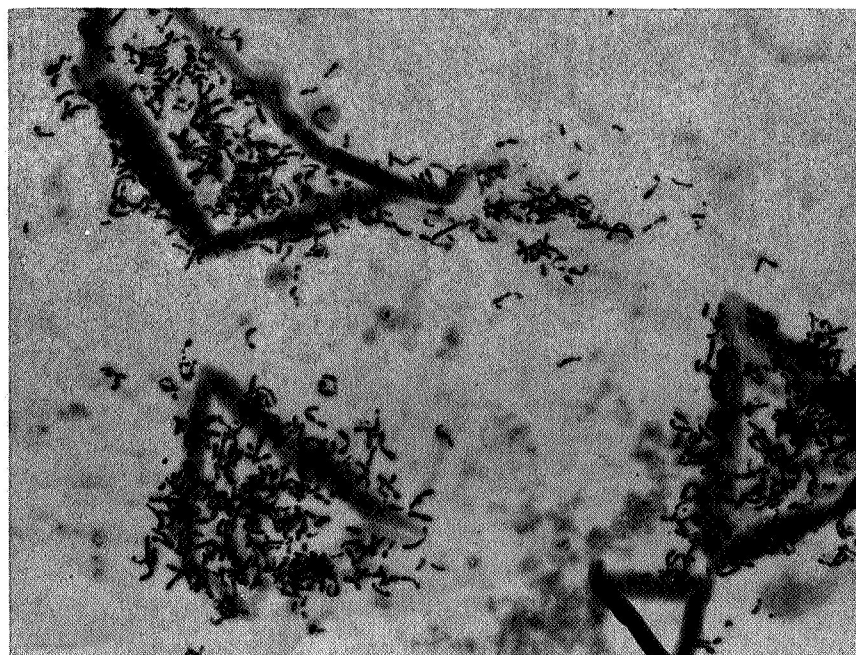
(a) 4,500X
(b) 15,500X

Figure 26. Microautoradiograph of Tritium in Ti-6Al-4V. Tritium is concentrated in the beta phase.

Attempts were made to determine the concentration of tritium in beta phase of alpha-beta alloys shown in Figures 26, 27 and 28 by counting the filaments on the electron microautoradiographs, and by calculating the efficiency of the nuclear track emulsion to the beta particles of radioactive tritium. The efficiency of the nuclear track emulsion was estimated using the specimen of Ti-5Al-2.5Sn with 48 ppm tritium as the reference material (see Appendix A). The concentration of atoms causing these filaments is calculated by the expression

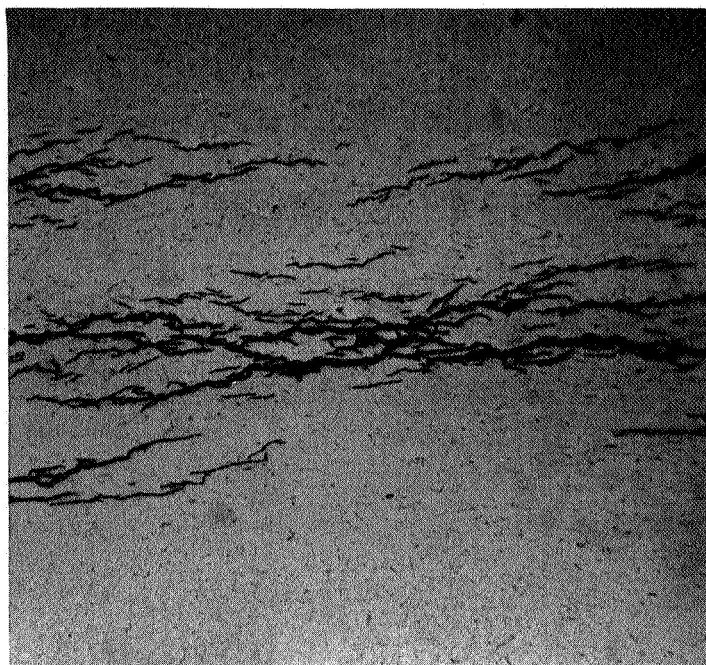
Figure 27. Development of Cracks in Ti-5Al-2.5Sn Due to Charging of 48 ppm Tritium at 725°C. Magnification 175X

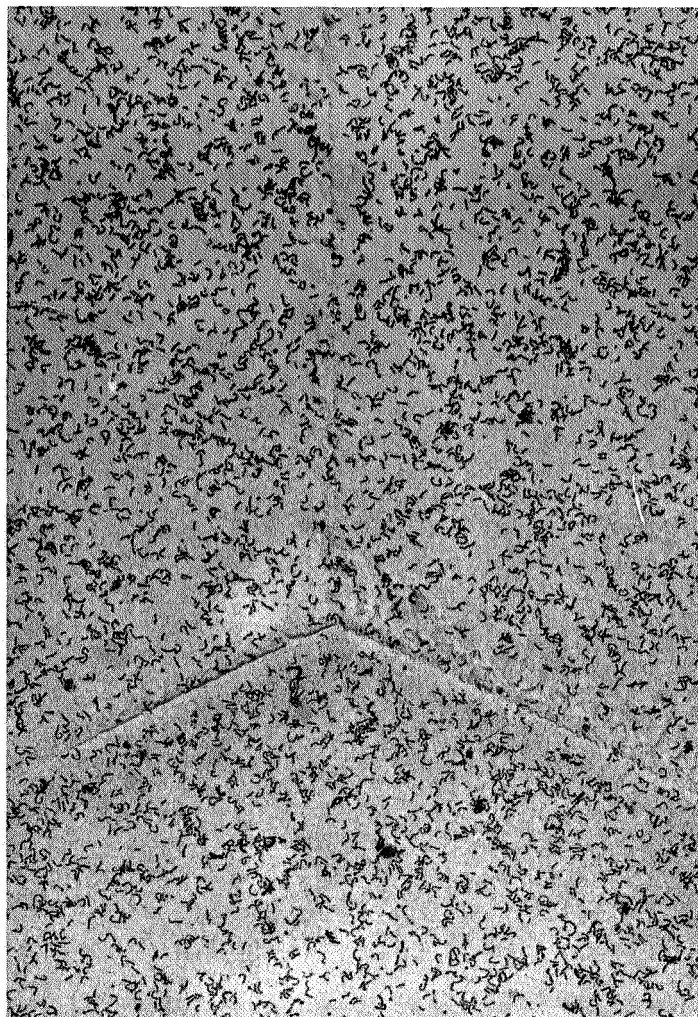
Figure 29. Microautoradiograph of Tritium in Ti-13V-11Cr-3Al (72 ppm). Magnification 8,375X.

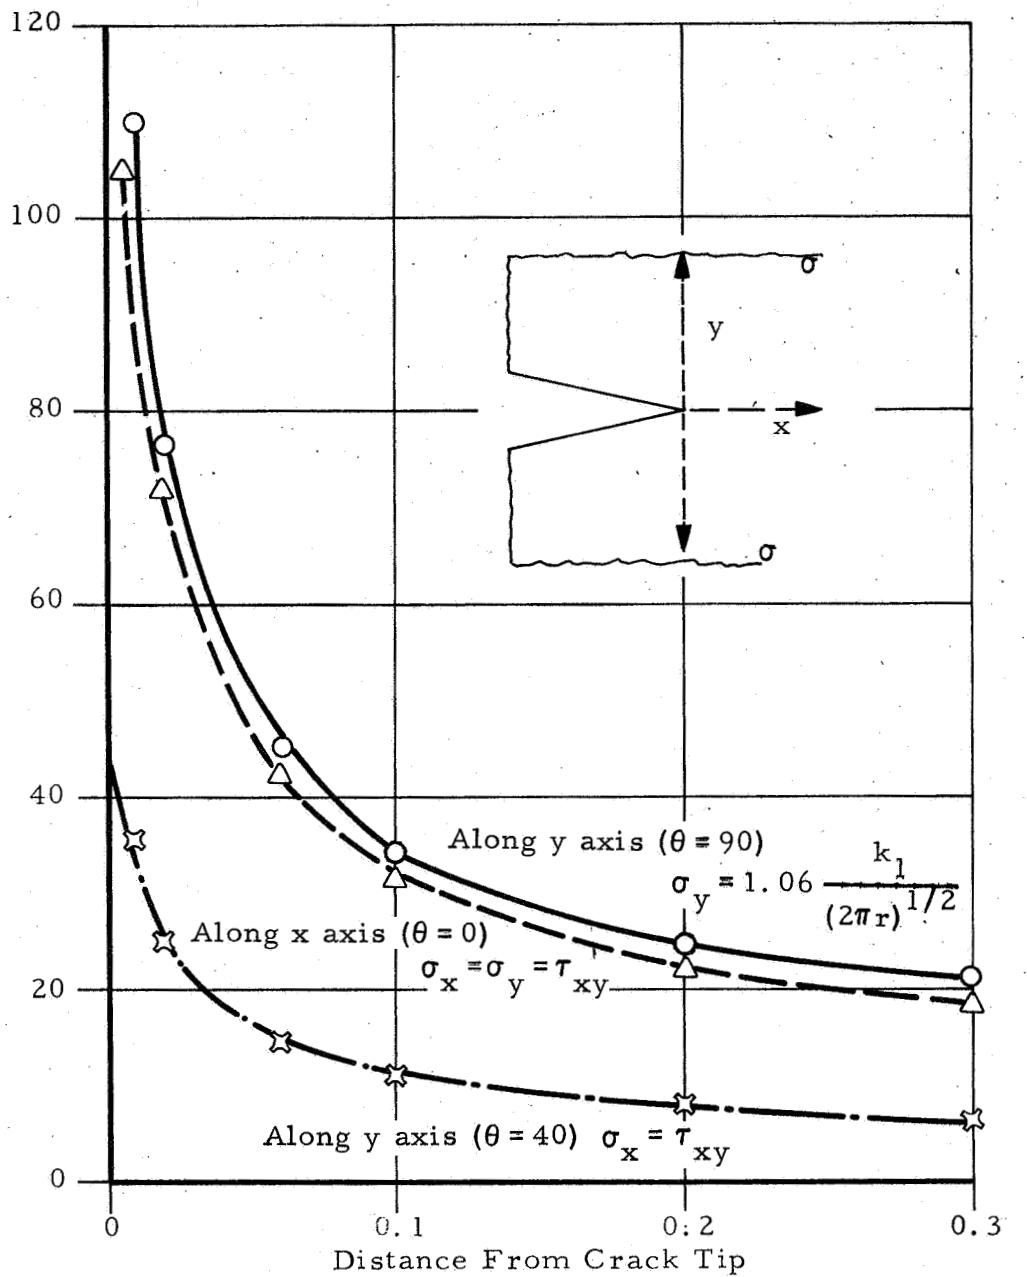
Figure 30. Stress Distribution Around a Crack Tip For $K_I = 26 \text{ ksi} \sqrt{\text{in.}}$

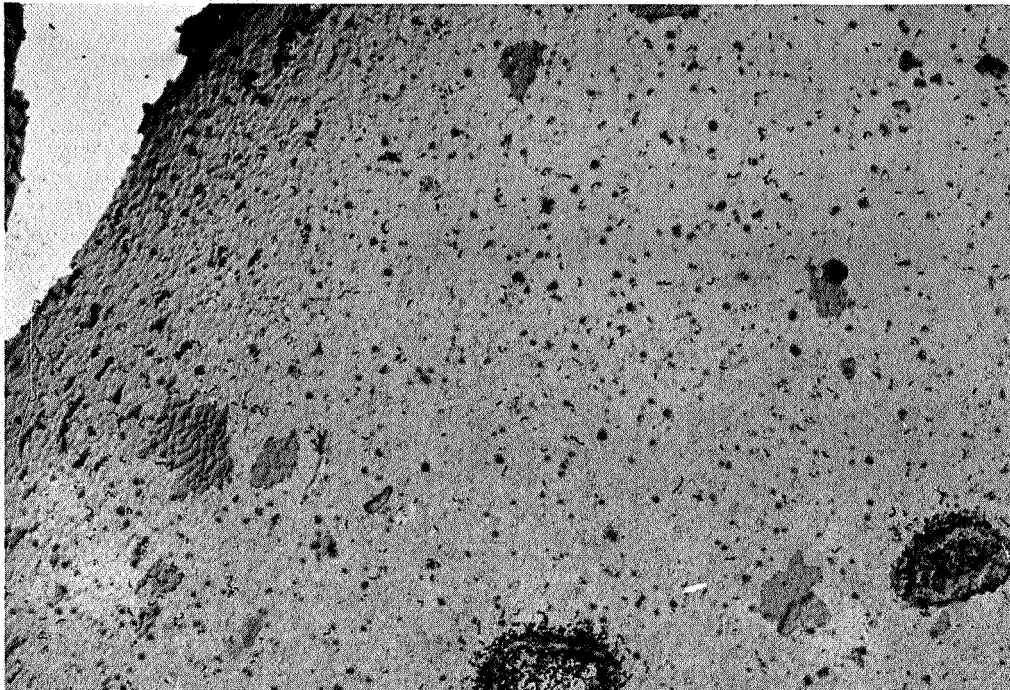
Figure 31. Microautoradiograph of Stressed Single Edge Notched Precracked Tritiated Ti-5Al-2.5Sn Specimen, Stress Intensity $50 \text{ ksi} \sqrt{\text{in.}}$. Magnification 10,000X.

The microautoradiographs of the entire grid samples around fatigue crack tip did not show any redistribution of tritium in the alpha matrix or in the beta phase at the stress intensity levels of 25 and 50 ksi√in. of Ti-5Al-2.5Sn and Ti-6Al-4V. The typical results for Ti-5Al-2.5Sn and Ti-6Al-4V are illustrated in Figures 31 through 33.

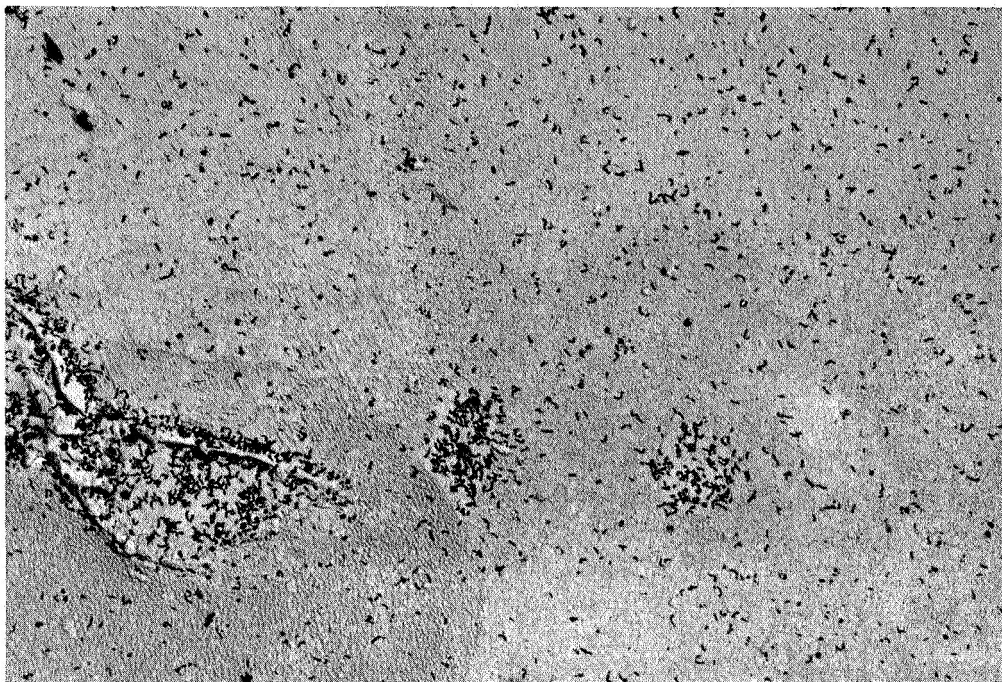
Figure 32. Microautoradiograph of Tritium in Ti-5Al-Sn
Within 0.001 Inch of Fatigue Crack Single Edge
Notched Specimen, Stress Intensity $25 \text{ ksi} \sqrt{\text{in.}}$.
Magnification 10,000X.

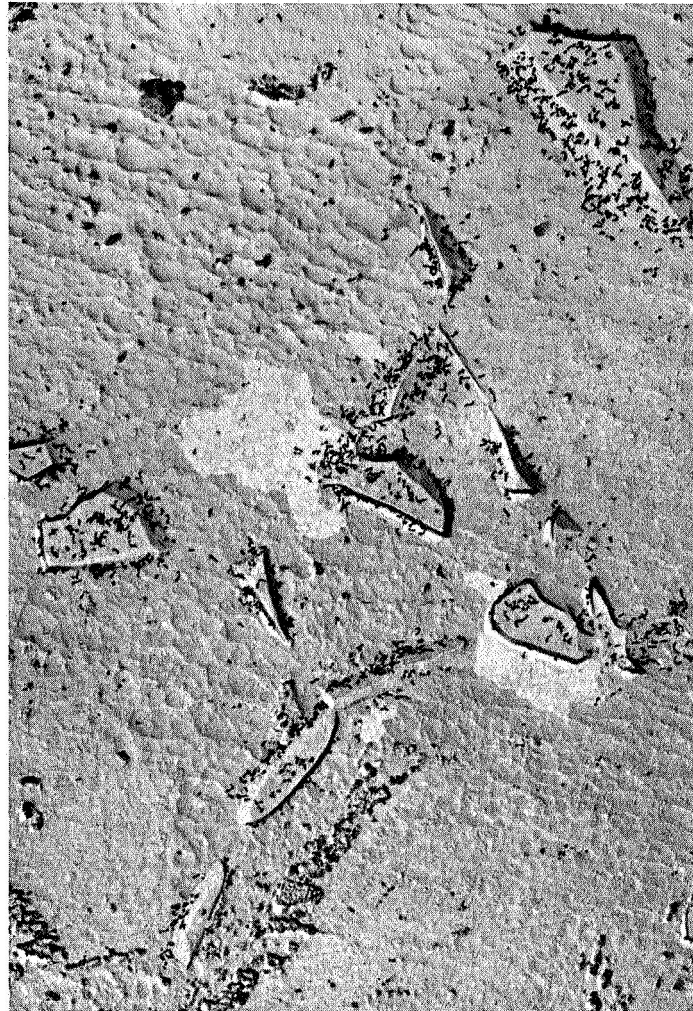
Figure 33. Microautoradiograph of Tritium in Ti-6Al-4V
Within 0.001 Inch of Fatigue Crack Single Edge
Notched Specimen, Stress Intensity $50 \text{ ksi} \sqrt{\text{in.}}$.
Magnification 10,000X.

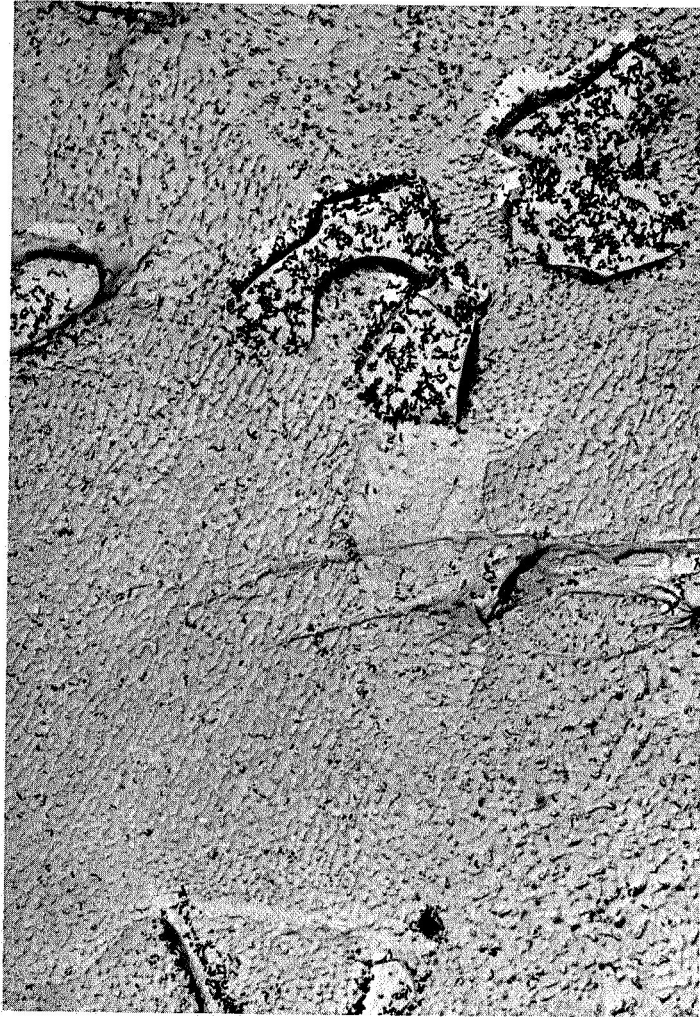
Figure 34. Microautoradiograph of Tritium in Ti-6Al-4V at Crack Tip of Fatigue Crack Single Edge Notched Specimen, Stress Intensity $25 \text{ ksi}\sqrt{\text{in.}}$. Magnification 10,000X.

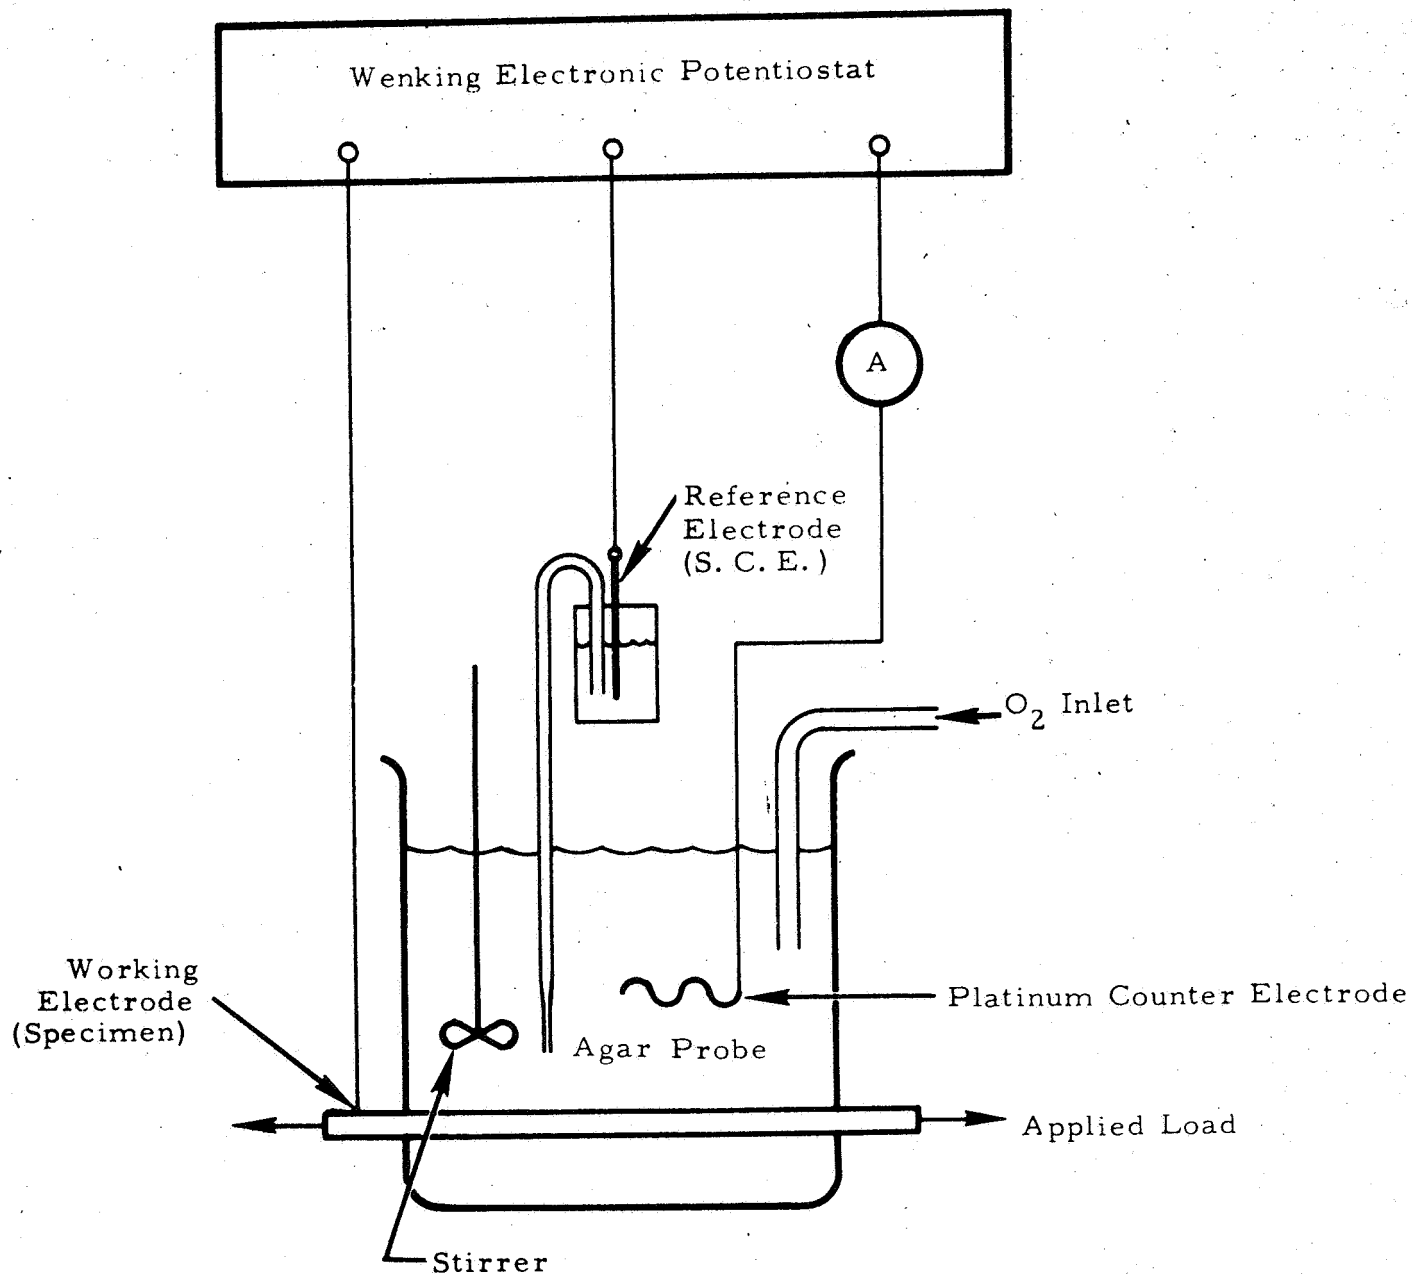
Figure 35. Schematic of Potentiostatic Experimental Arrangement

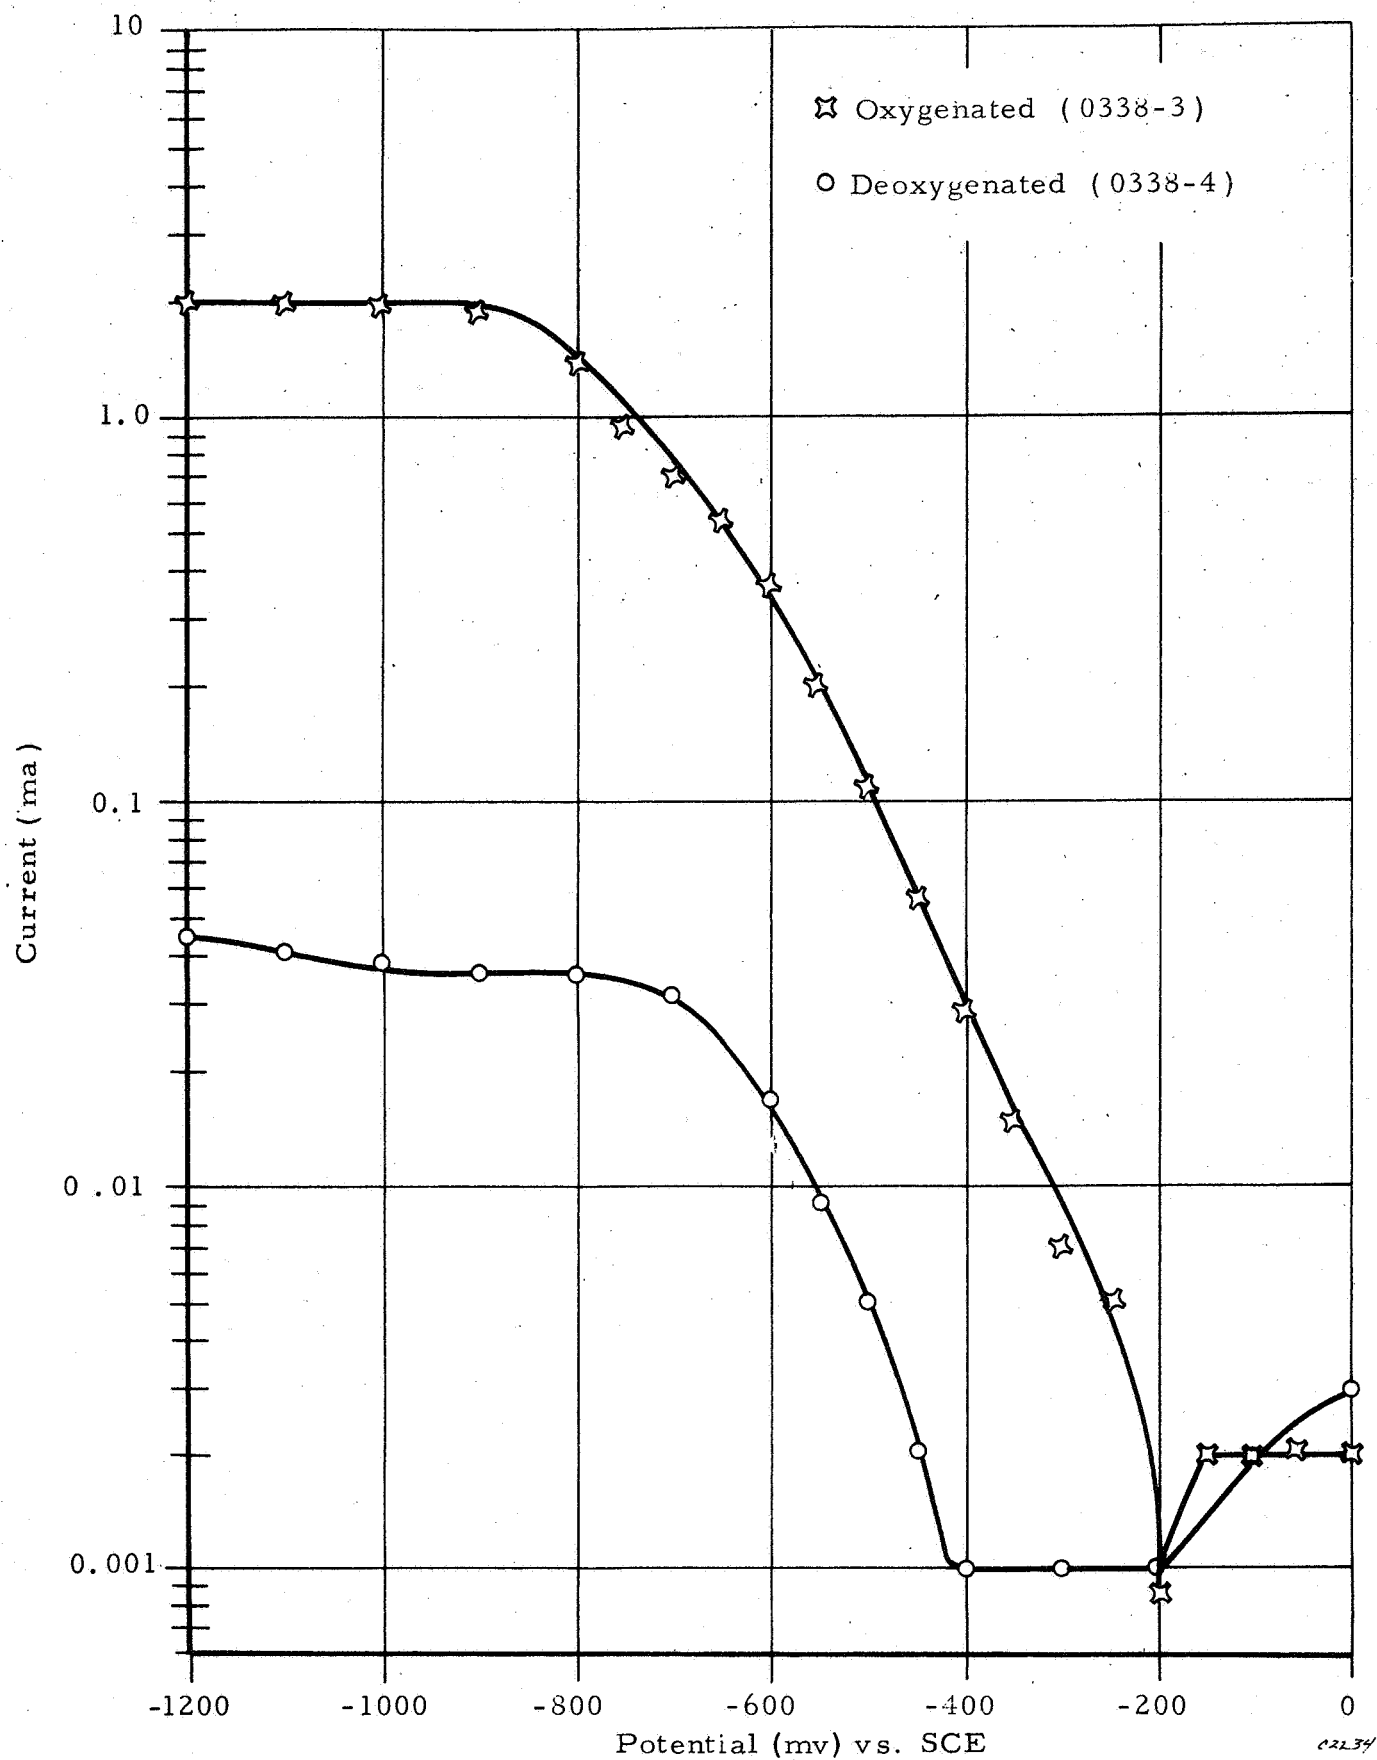
Figure 36. Effect of Oxygenation on the Polarization Curves of Ti-5Al-2.5Sn in 3% NaCl

The large increase in current density with oxygenation indicates the strong depolarization effect due to oxygen. Thus it is apparent that cathodic reduction of oxygen $\text{O}_2 + 4e \rightarrow 2\text{H}_2\text{O}$ also contributes to the cathodic

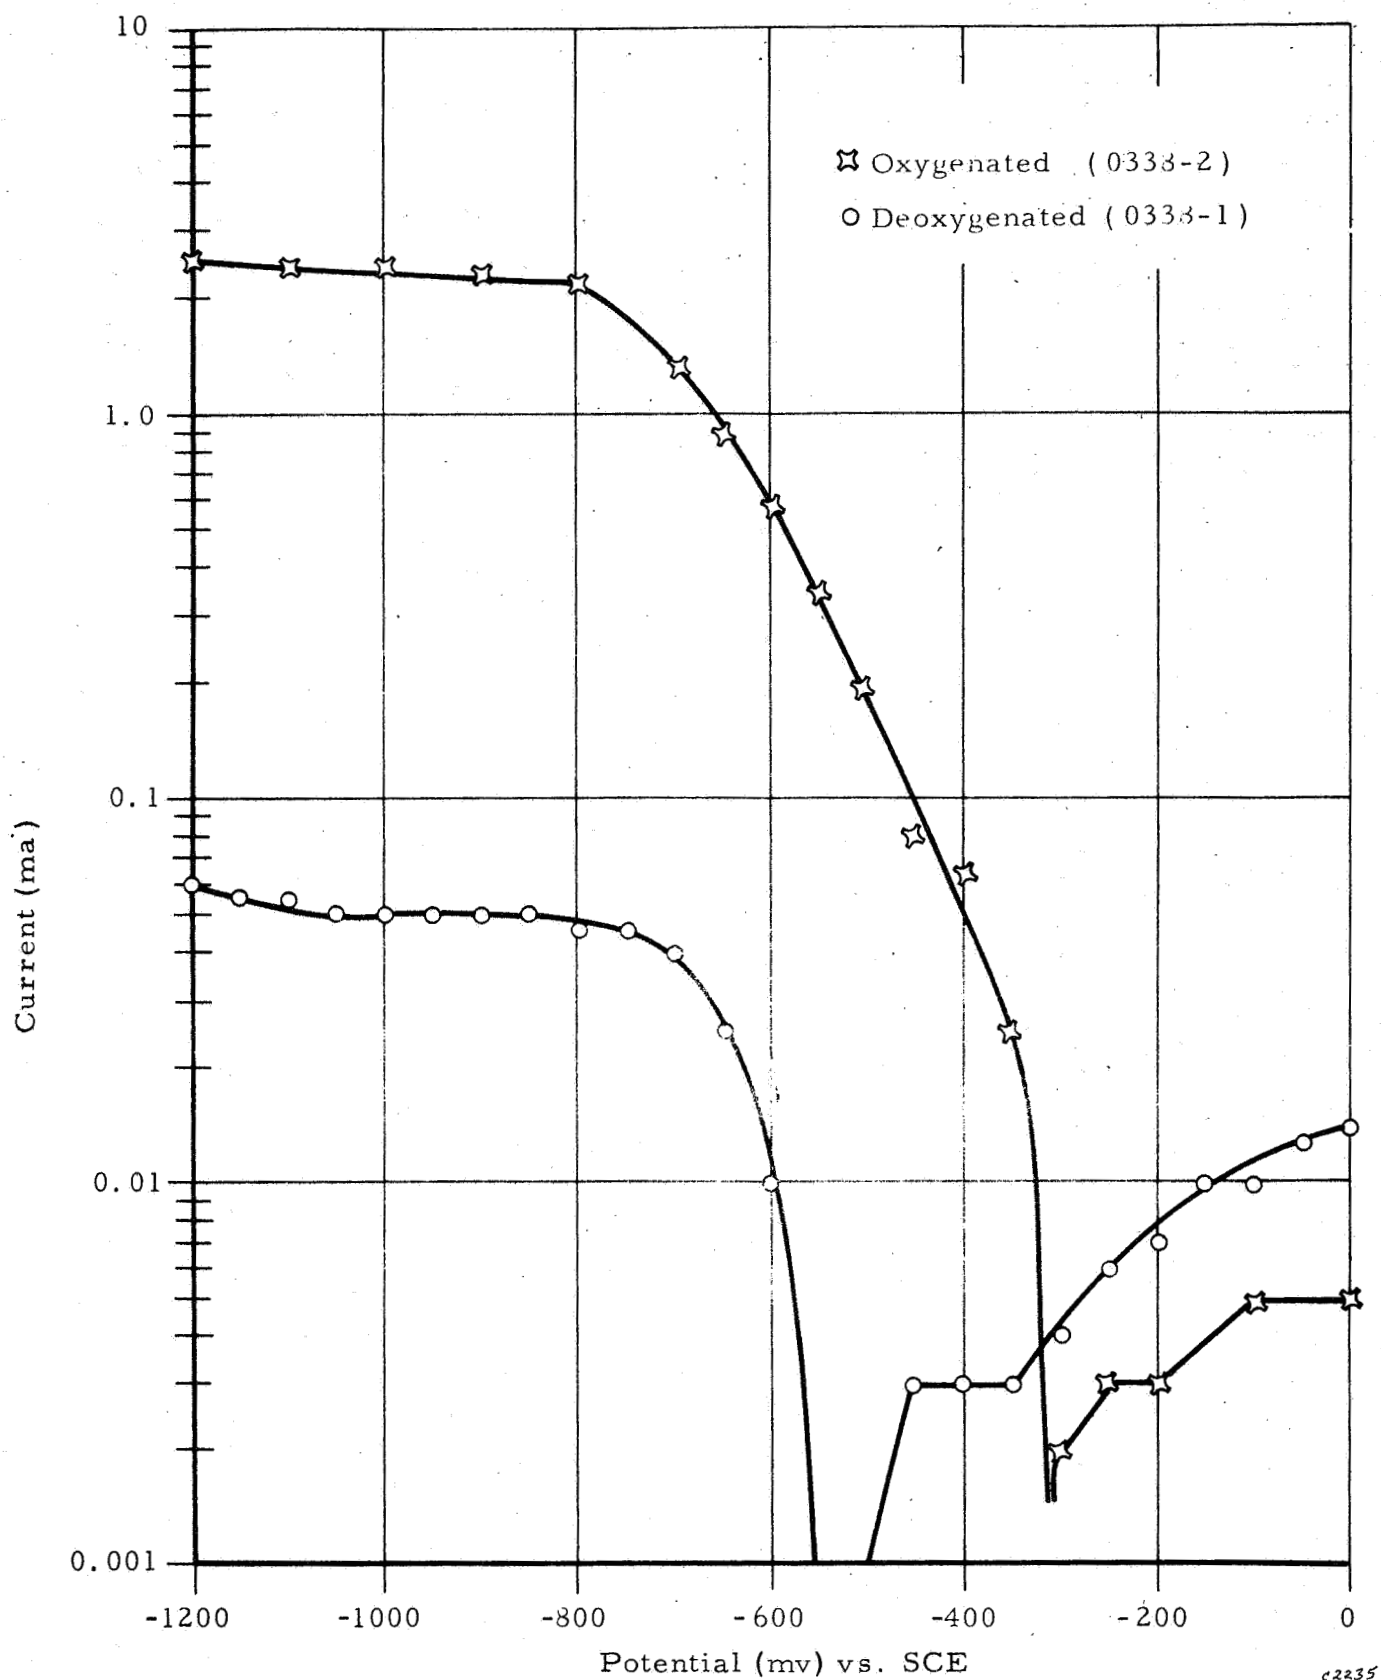
Figure 37. Effect of Oxygenation on the Polarization Curves of Ti-6Al-4V in 3% NaCl

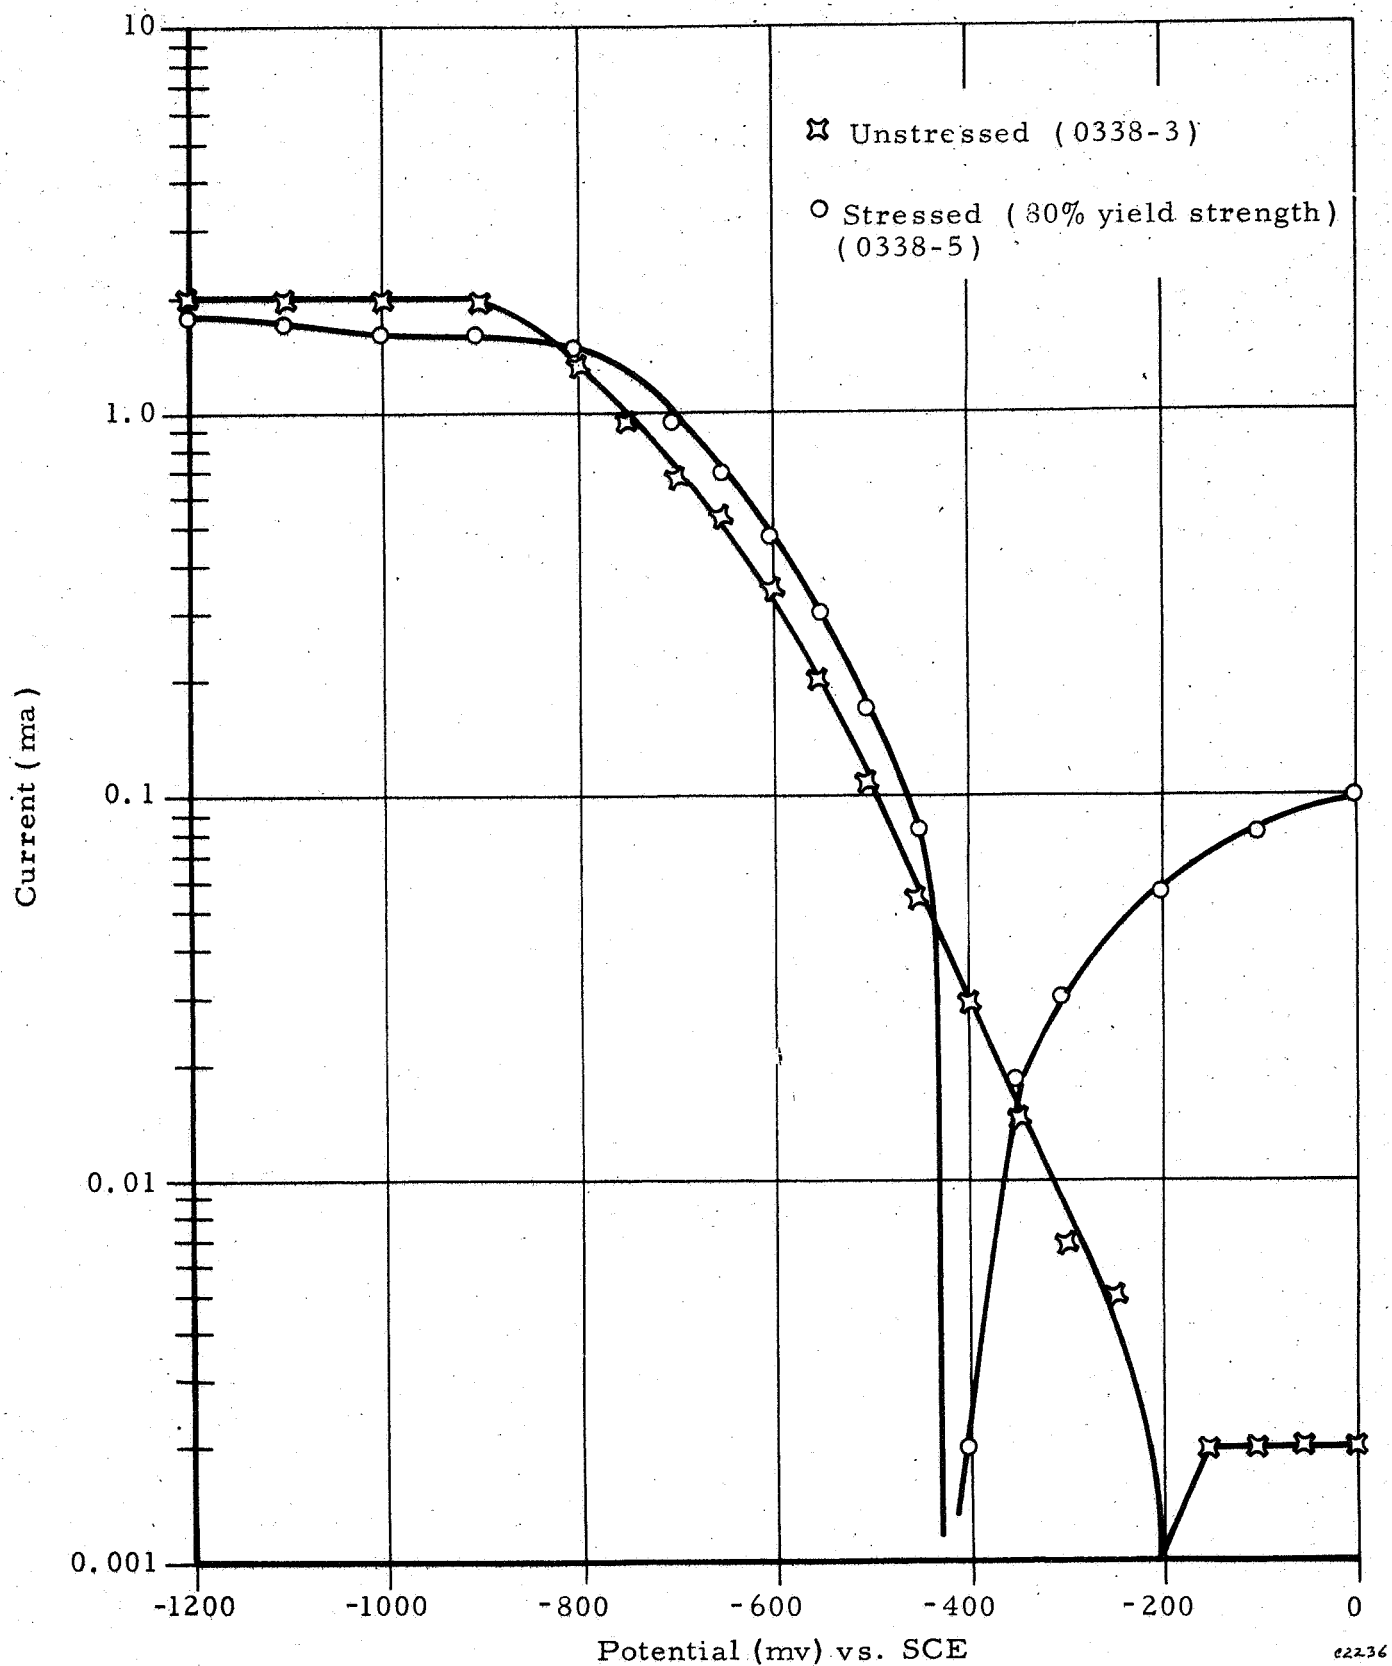
Figure 38. Effect of Stress on the Polarization Curve of Ti-5Al-2.5 Sn in 3% NaCl
